CONNECTICUT RIVER BASIN  
WINCHESTER, CONNECTICUT

**HIGHLAND LAKE DAM**  
**CT 00106**

PHASE I INSPECTION REPORT  
NATIONAL DAM INSPECTION PROGRAM

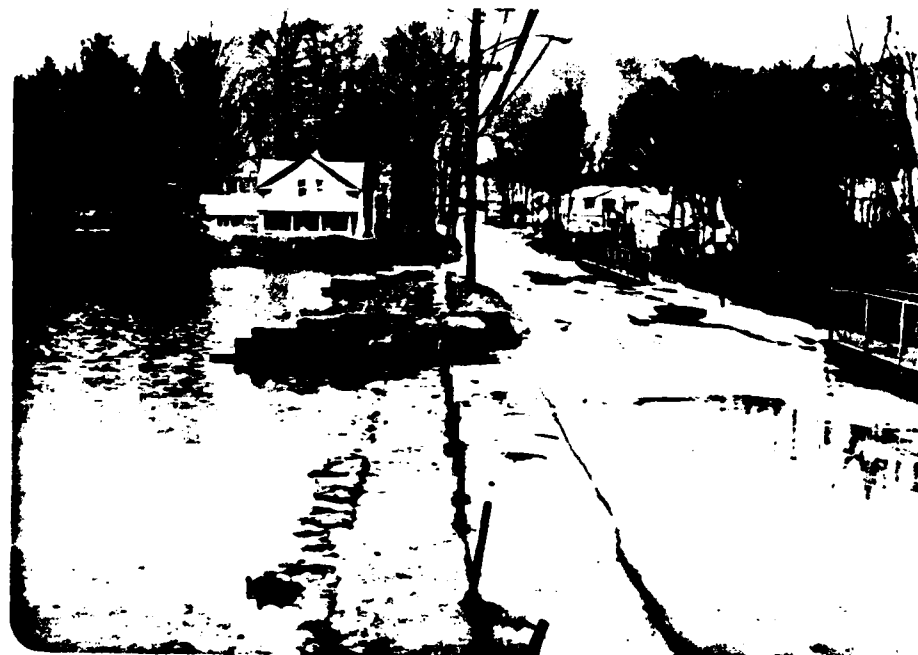
Crest - The crest of the dam serves as a roadway and is paved with a blacktop surface which is in fairly good condition (Appendix C, photo 1). Only a slight amount of surface cracking was observed in the pavement. The dam and roadway were constructed such that two 75 foot sections of the road acting as spillways are at an elevation approximately 1.5 feet lower than the rest of the road across the dam. The crest is approximately 40 feet wide, including a sidewalk and chain link fence along the downstream edge of the crest. Pedestrian traffic over the spillway sections is accommodated by boardwalks (Photos 5 & 6). A chain link fence exists along the upstream as well as the downstream edge of the boardwalks. Overhead utility lines run the length of the dam along the upstream edge of the roadway with 4 poles on the dam itself. There is a concrete floodwall along the upstream edge of the crest between the right spillway and the boat launching ramp at the right end of the dam (Photo 3). The concrete wall was built in 1973, and is in good condition. There are three openings in the wall to allow for access to the gatehouse and to boating facilities. The openings may be closed against rising waters by use of steel doors hinged on the wall at each opening.

Appurtenant to the dam at both the right and left abutments are earth dikes (Photo 2) which appear to be well maintained and in good condition, however, little is known about their construction. The crest and downstream slopes are covered with grass which appears to be mowed regularly, while the upstream slopes are protected by dumped rock riprap which, in general, is in good condition. On the dike to the right of the dam are four sets of concrete steps leading to the water. All of these appear in good condition and provide access to the water while eliminating the need for trespassing on the slopes. The dike at the left end of the dam is set back about 15 feet from the water's edge (normal pool elevation) where there is a dry-laid stone wall in good condition and several pine trees which do not appear to be detrimental to the dike (Photo 1).

PHOTO 1 - General view of crest of dam, showing the two spillways, boardwalks and dike at left end of dam.

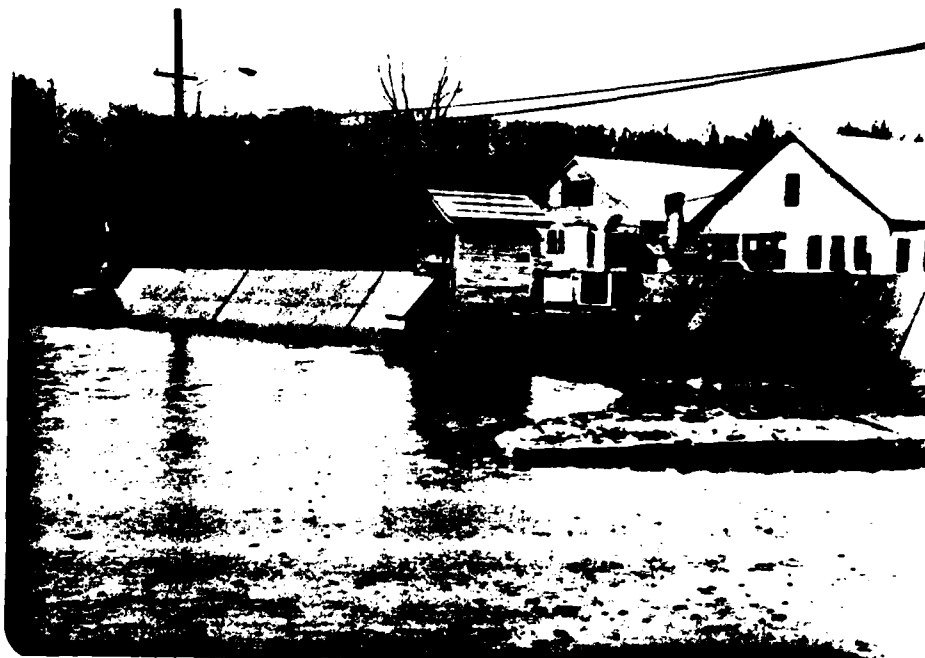
the spillway is the new concrete floodwall, on a batter of 12 vertical on 9 horizontal upstream, and vertical downstream (Photo 3). At the extreme right end of the dam where the floodwall is adjacent to the boating facilities, it is vertical upstream, and on a batter of 12 vertical on 9 horizontal downstream. The concrete of the floodwall is in good condition with no evidence of cracking or spalling. The steel gates in the wall appeared to be functional and in good condition.

PHOTO 3 - Gatehouse and concrete floodwall. Note steel gate in floodwall behind gatehouse to provide access to gatehouse.

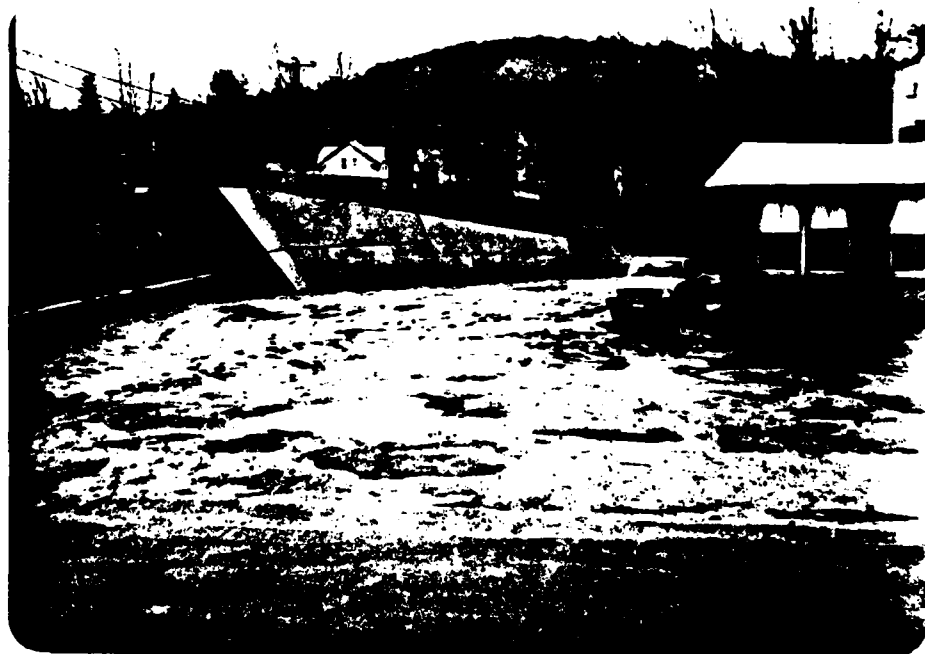
Downstream of the dam and to the left of the parking lot is a concrete training wall designed to confine overflow from the right spillway to its channel and away from the parking lot. The wall, built in 1973, is in good condition. At the upstream end of the wall is a sleeve through which the gas line attached to the downstream face of the dam passes (Photo 9). According to several 1974 newspaper articles, there had been a problem with water passing through the sleeve, however, the hole is apparently now sealed around the pipe.

PHOTO 4 - Downstream concrete training wall designed to confine overflow of right spillway to channel in background and out of parking lot in foreground.

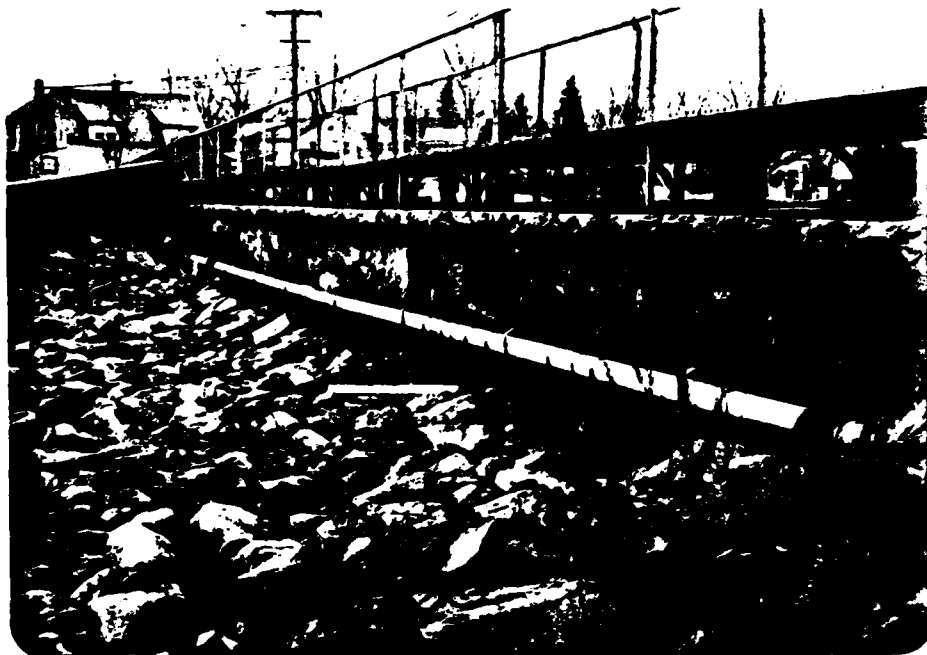
Downstream Face - The downstream face of the dam is a dry-laid granite block wall of undetermined thickness and with a maximum height of approximately 14 feet (Photos 5, 6 and 9). The wall is in good condition although it has many gaps between blocks where the roughly cut rock could not be laid tightly. Sand was observed in several of these gaps indicating a possible loss of material from within the dam. Along the two spillway sections the wall is capped with a more finely cut rock slab, while there was no cap along the other portions of the wall. A gas line is fastened to the outside of the wall with metal straps for nearly the entire length of the dam.

5. A rupture of the gas pipe along the downstream face of the dam during an emergency situation could cause a considerable worsening of conditions at the dam.

The spillways are part of a roadway, and therefore are spanned by a fenced-in boardwalk for pedestrian traffic. The boardwalk and fences are liable to become blocked due to floating debris. It appears that the pipe supports for the fence are anchored into the top of the downstream stonewall portion of the dam. It is conceivable that during heavy flows, debris caught by the fence and boardwalk could cause the water to exert enough pressure on the fence to cause it to break away from its anchoring, resulting in displacement and damage to the masonry portion of the dam.

PHOTO 5 - Downstream face of right spillway. Note gas pipe along masonry wall, and potential for obstruction due to boardwalk and fence.

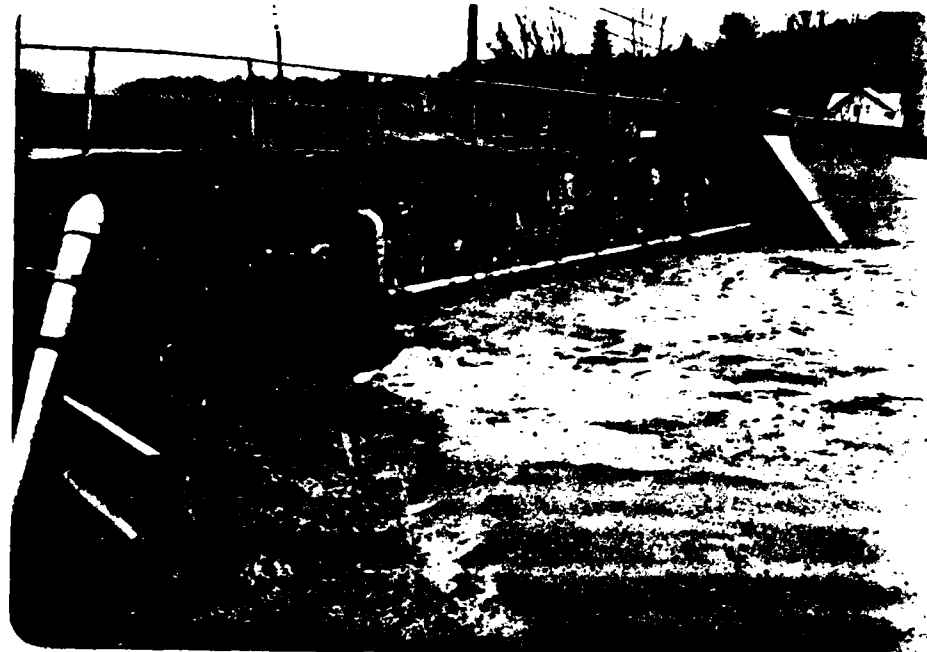
PHOTO 9 - Downstream face of dam to right of spillway. Short section of open channel from arch culvert and to concrete culvert beneath parking lot is in foreground. Note gas line passing through concrete training wall in background.

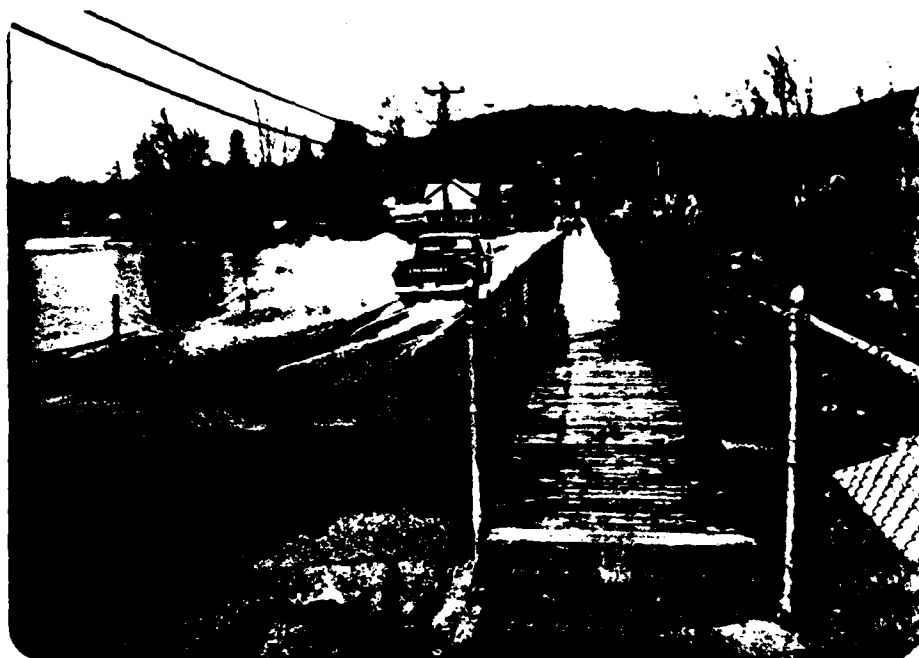
PHOTO 11 - View from right end of right spillway under over-flowing conditions.

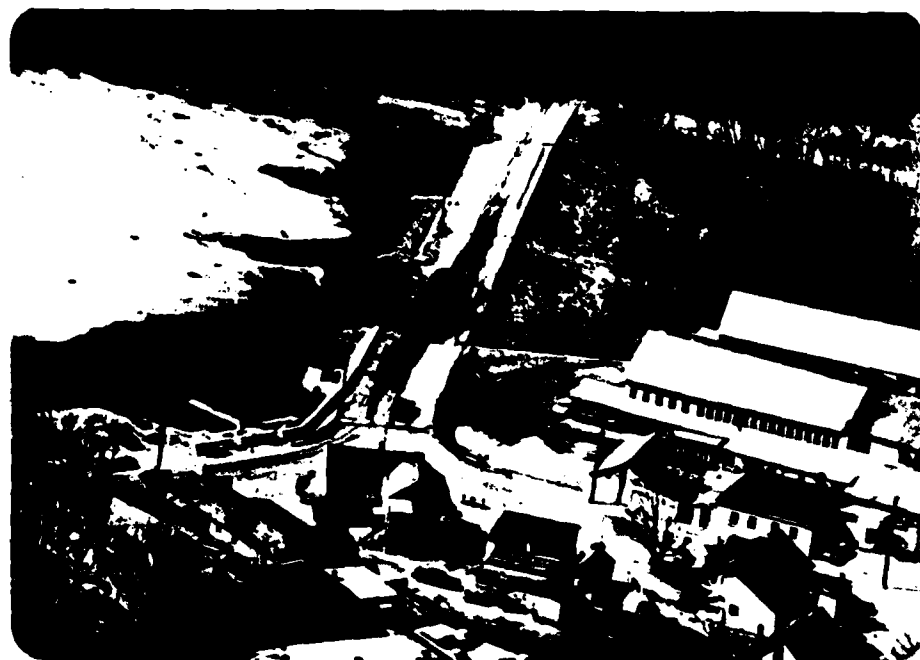
PHOTO 12 - Aerial view of dam. Note flow over right spillway while left spillway is dry.
